# A FLOOD PLAIN MANAGEMENT STUDY

For the Town of  
Strafford, Vermont

FLOOD PLAIN MANAGEMENT STUDY  
TOWN OF STRAFFORD  
ORANGE COUNTY, VERMONT

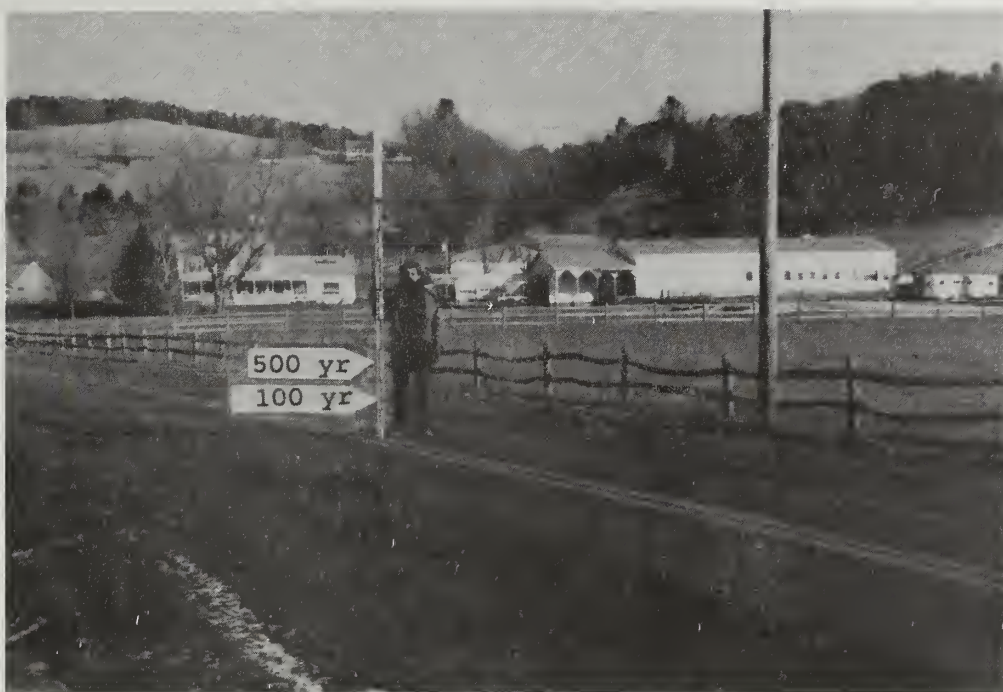
**Figure 3.** On Rt. 132 in Strafford near Huntington Farms at section WB24

Figures 1 through 4 show the water surface level of the 100 and 500-year flood at selected localities.

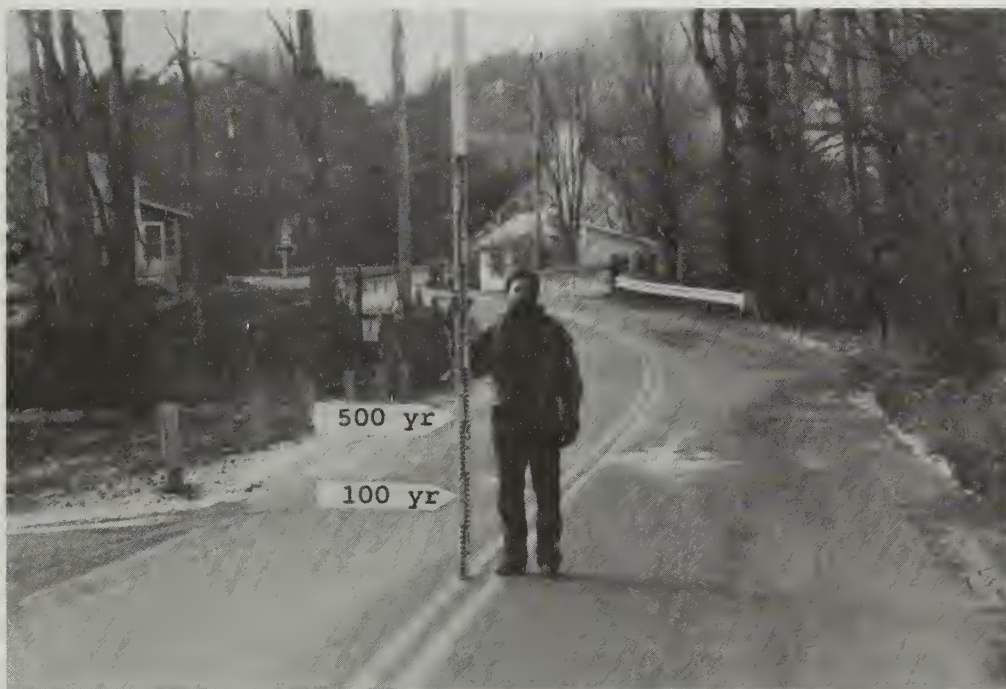
**Figure 4.** On Rt. 132 in South Strafford near Corburn's Store at section WB32

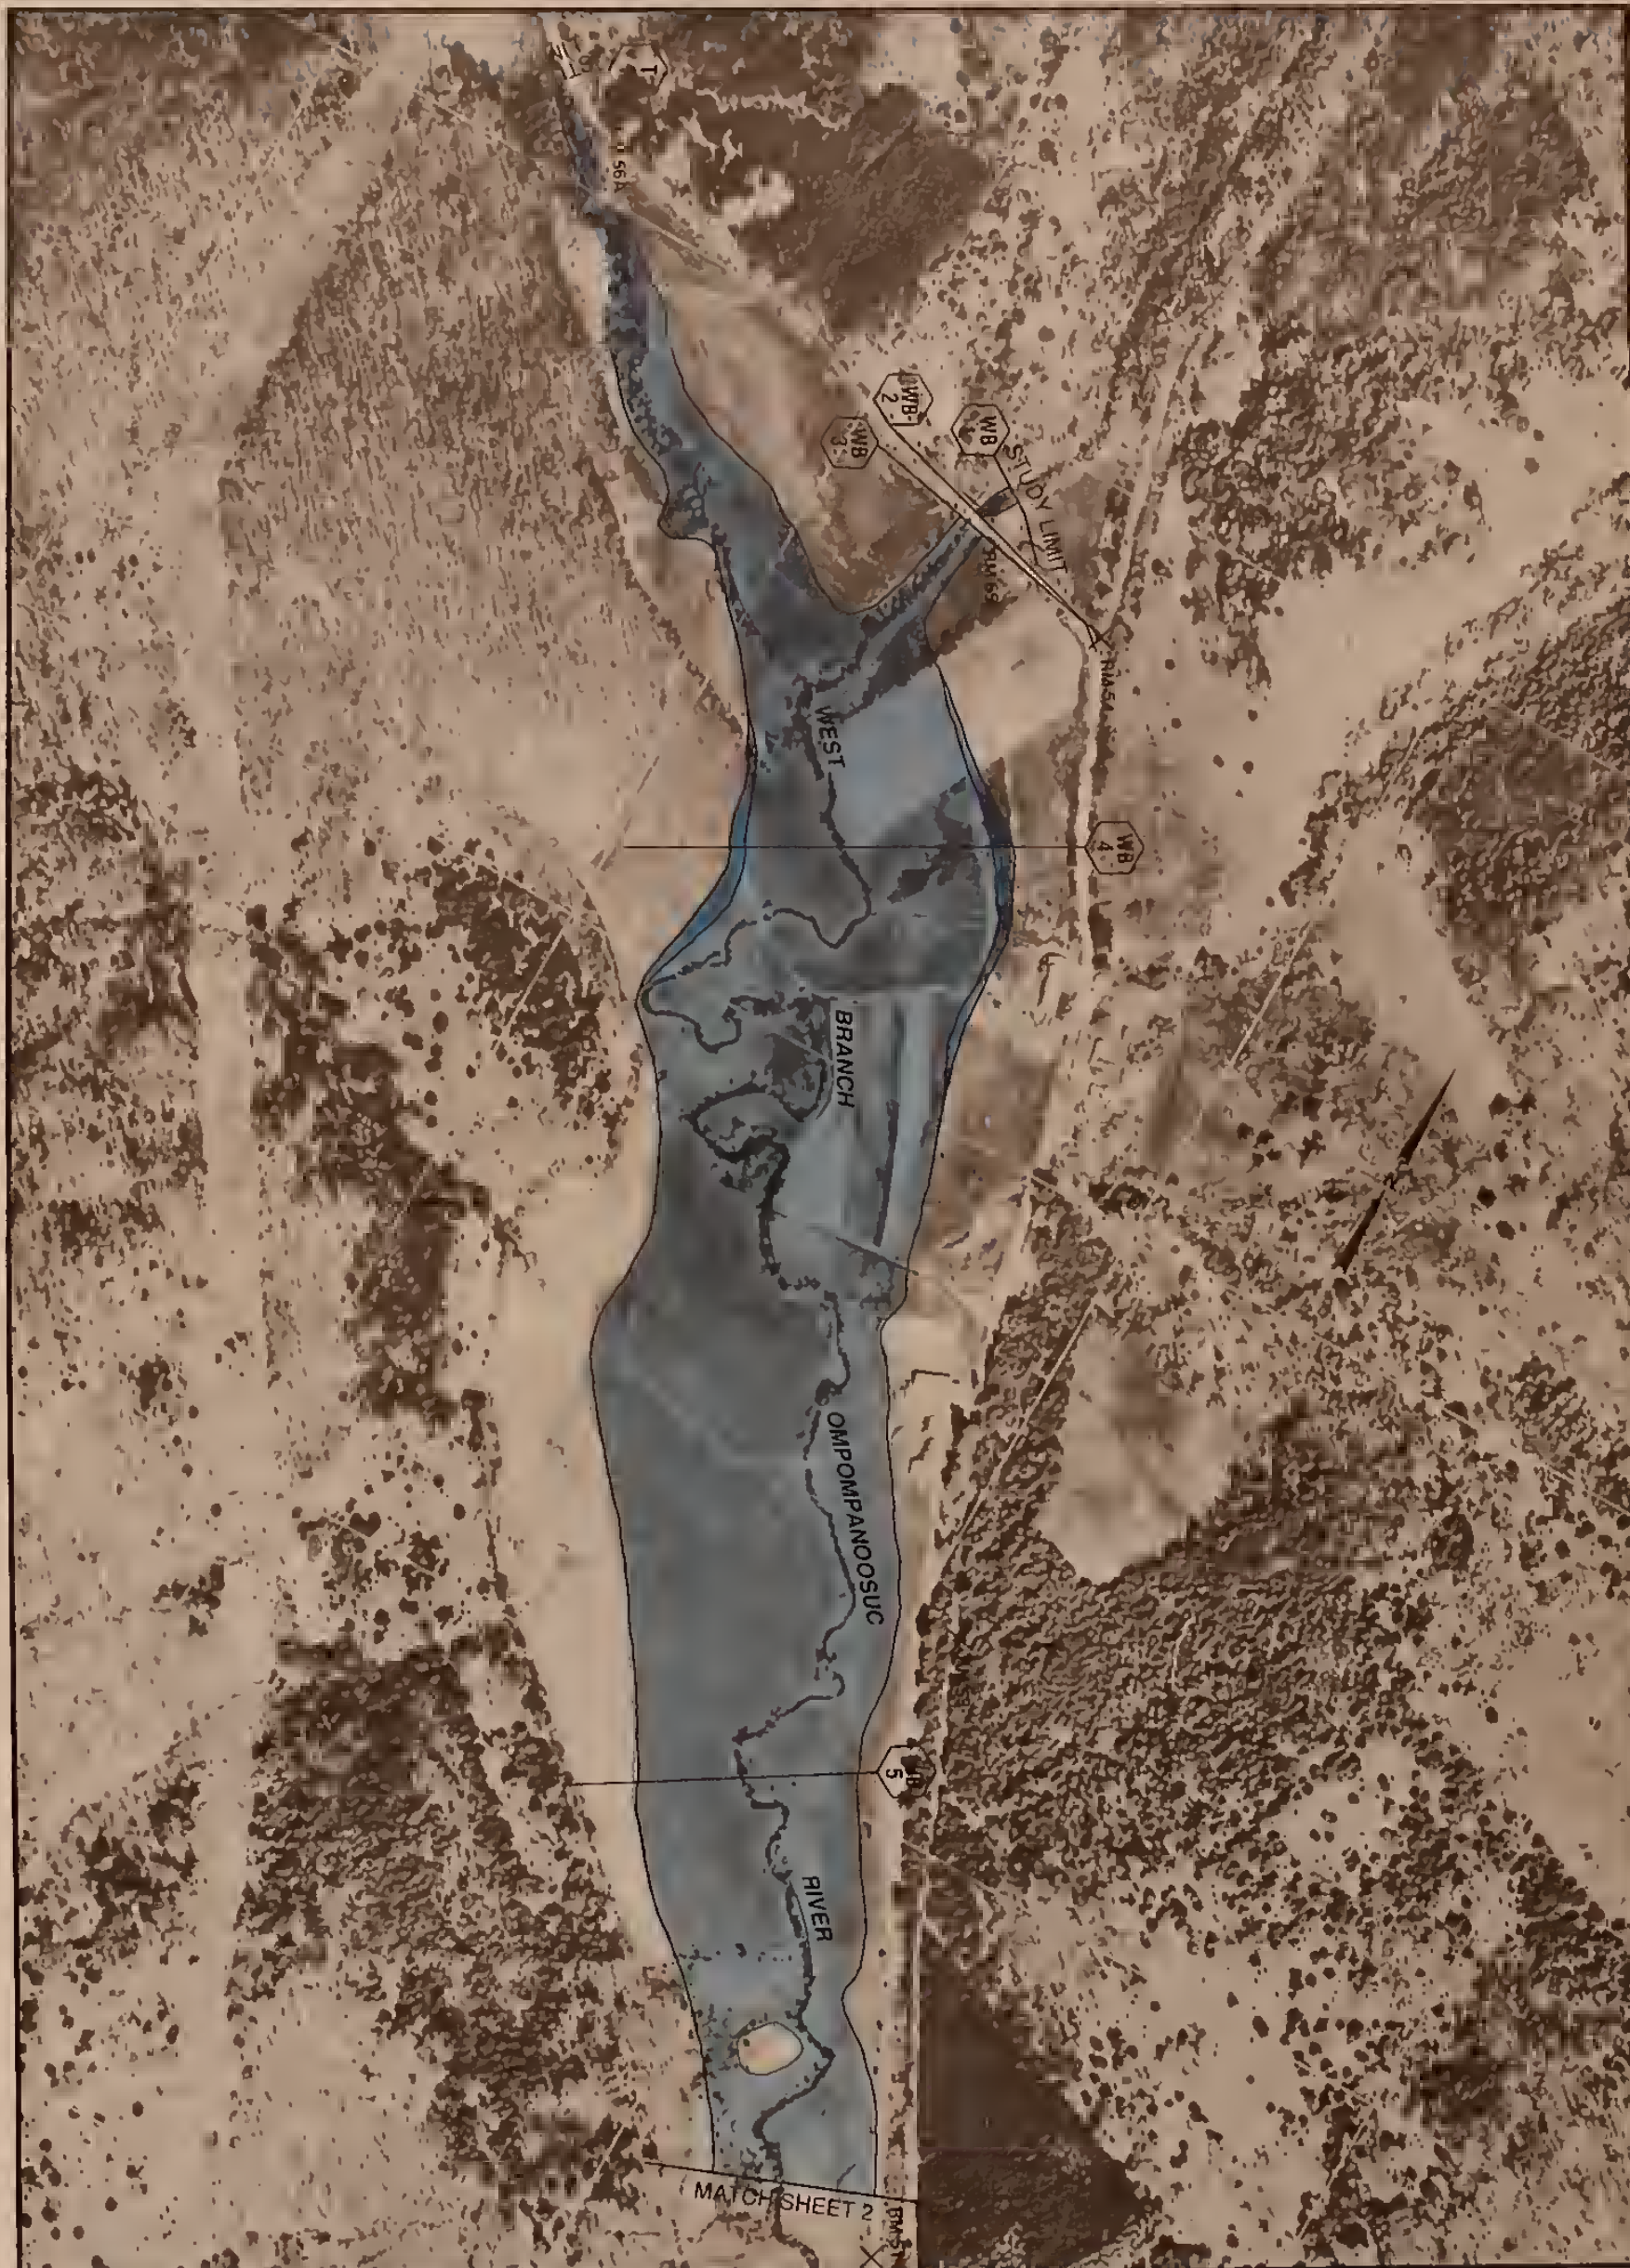
- 100 YEAR FLOOD AREA
- 500 YEAR FLOOD AREA
- SURVEYED CROSS SECTION

# FLOOD HAZARD AREA

The photomaps entitled "Flood Hazard Areas" (sheets 1 through 6 in Appendix A) show the 100-year and 500-year flood areas. These areas are depicted based on present land use and management conditions. The flood boundaries show the approximate location on the ground for general reference purposes. The 500-year flood boundary is to be interpreted as being close to the 100-year flood boundary where it is not separately mapped. The reason for this is that the valley side slopes along many reaches of stream are steep and the map scale small. This yields a 500-year boundary which is nearly contiguous with the 100-year boundary. Along such reaches it is therefore not mapped.
